Emissions Leak Test Failure

Maintenance Guide

Vehicle Exhaust Gas Analyser (VEGA) Fault Finding

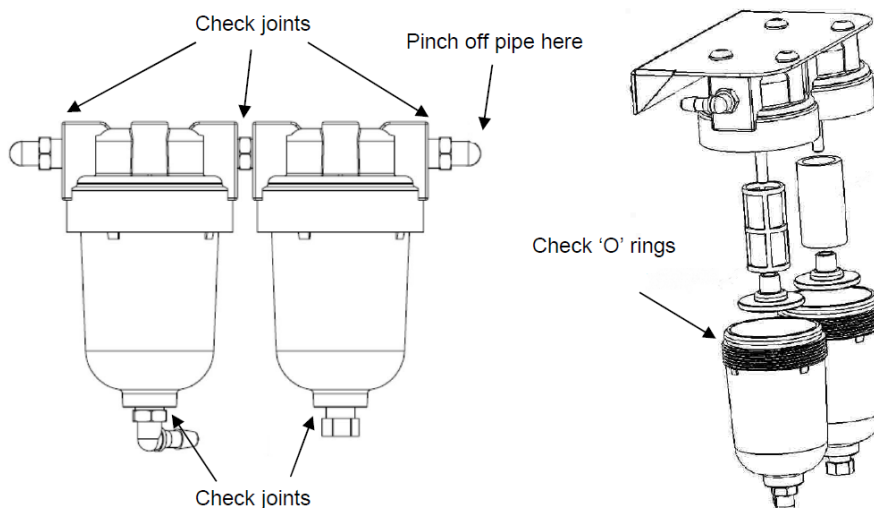
- If the test still fails, 'pinch off' the pipe immediately after the gas filter bowl (see below) and retest. If problem cured, check all joints on sample inlet and filter bowl assembly, particularly the bowl to bowl adapter
- Unscrew filter bowls and ensure the 'O' rings are in good condition and have not been 'pinched' during assembly
